REPAIR OF MECHANICALLY-DAMAGED PIPES USING ARMOR PLATE PIPE WRAP

Christopher R. Alexander
Stress Engineering Services, Inc.

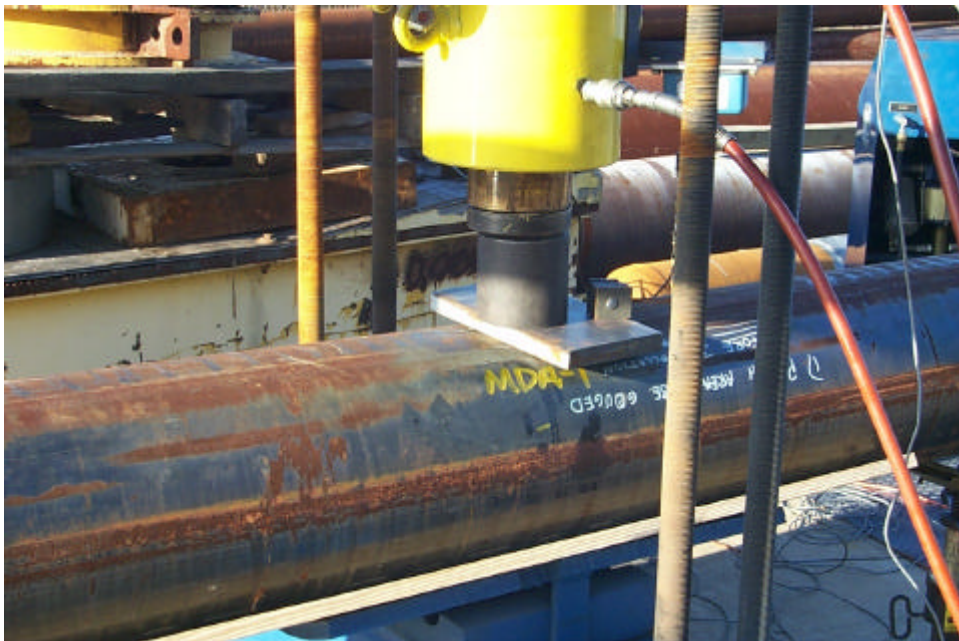
Figure 2 Close-up view of indenter plate creating dent in pipe

Figure 1 shows the indenter test rig used to install the dents, while **Figure 2** provides a close-up view of the indenter plate positioned on the pipe. The denting procedure was repeated to create four dents in each pipe sample. In the process of creating the dents measurements were made to acquire the dent profile and dent depth. **Table 2** provides the dent depth measurements for all of the test samples, while **Figure 3** plots the axial profile for Sample A4 and Sample B4. Note the significant level of rerounding that occurs in the dented region as a result of internal pressurization.

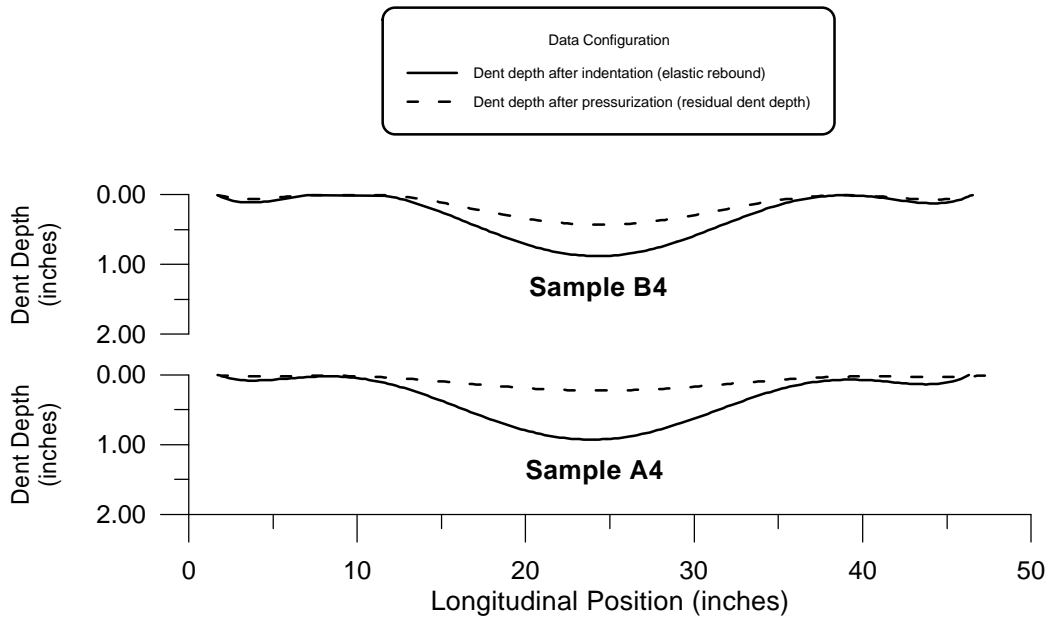
DENT DEPTH AS A FUNCTION OF LONGITUDINAL POSITION

Figure 3 Profile of dent depth along longitudinal axis of pipe

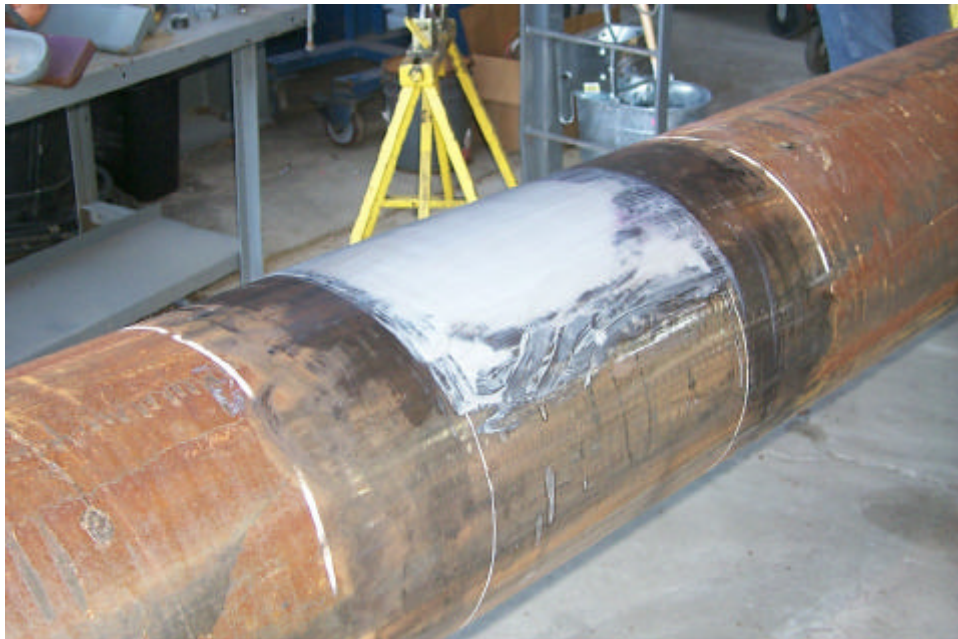
Figure 4 Filler material applied in dented region

1. Remove gouge by grinding with a hand-held grinder. Use dye-penetrant to ensure removal of crack at base of gouge. Measure remaining wall thickness using ultrasonic methods.
2. Fill dented region with epoxy-putty material to restore circular profile to outside surface of the dented pipe.
3. Install Armor Plate Pipe Wrap. In repairing mechanical damage, the minimum thickness of the wrap should be at least 1.5 times the thickness of the pipe wall.
4. When installing Armor Clamp, four layers of APPW should be installed.

mechanical damage (after gouge removal) is for the thickness of the wrap to be 1.5 times the thickness of the pipe wall thickness. Each layer of the wrap is approximately 1/16-in thick. Four layers of APPW were used in conjunction with the clamps. **Figure 4**, **Figure 5** and **Figure 6** show different stages of the wrap installation process.

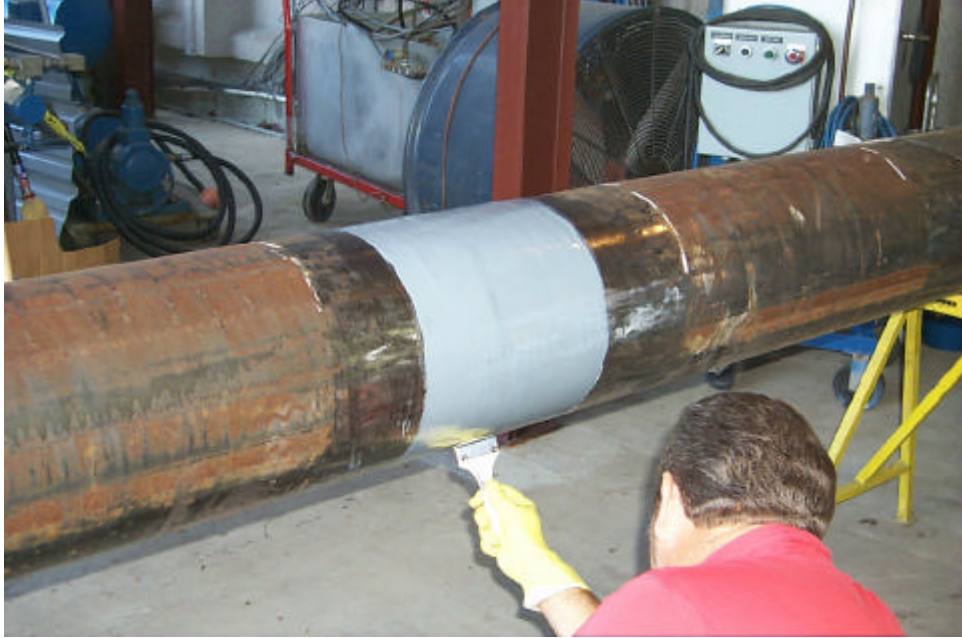
Figure 5 Application of epoxy primer

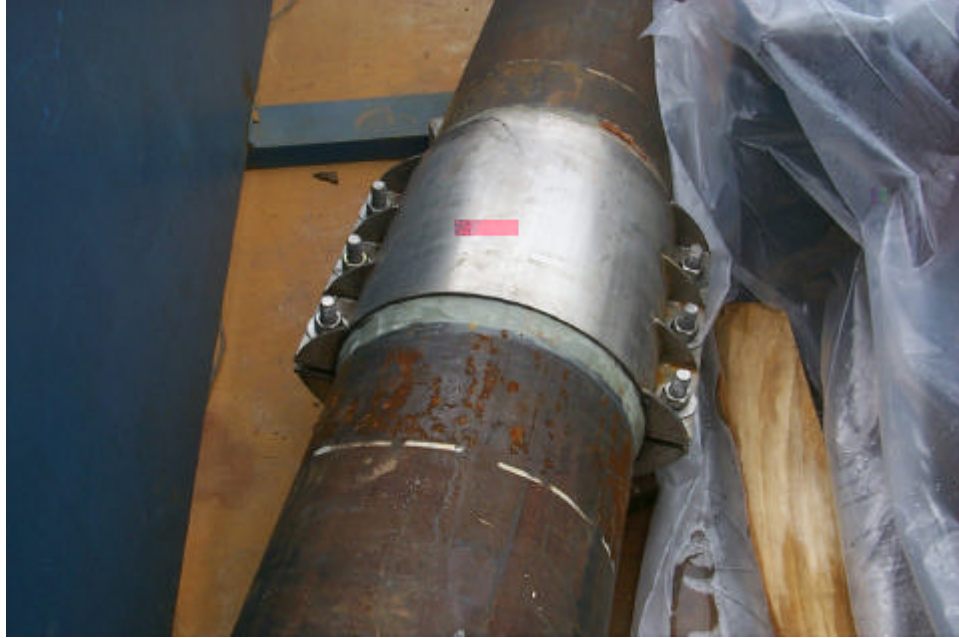
Figure 7 Stainless steel clamp used in conjunction with APPW

While the focus of this testing was on the use of Armor Plate in repairing mechanical damage, the recent development of a stainless steel clamp by Armor Plate, Inc. (used in conjunction with the composite wrap materials) was implemented into the fatigue test program. One clamp was installed on each of the pipe samples. **Figure 7** is a photograph of one of the clamps. As seen, the clamp is comprised of two halves that are bolted together. Both Sample A1 and Sample B1 involved four layers of APPW in addition to the clamps. The clamps are fabricated from 1/8-in 316 stainless steel material and are bolted together using six 3/4-in bolts. Prior to their installation, the APPW sleeves were applied and permitted to cure. The surfaces of the wrap were ground smooth and grease was applied to reduce friction during the bolt-tightening process. The bolts were tightened to 125 ft-lbs which corresponded to an approximate bolt stress of 52,000 psi.

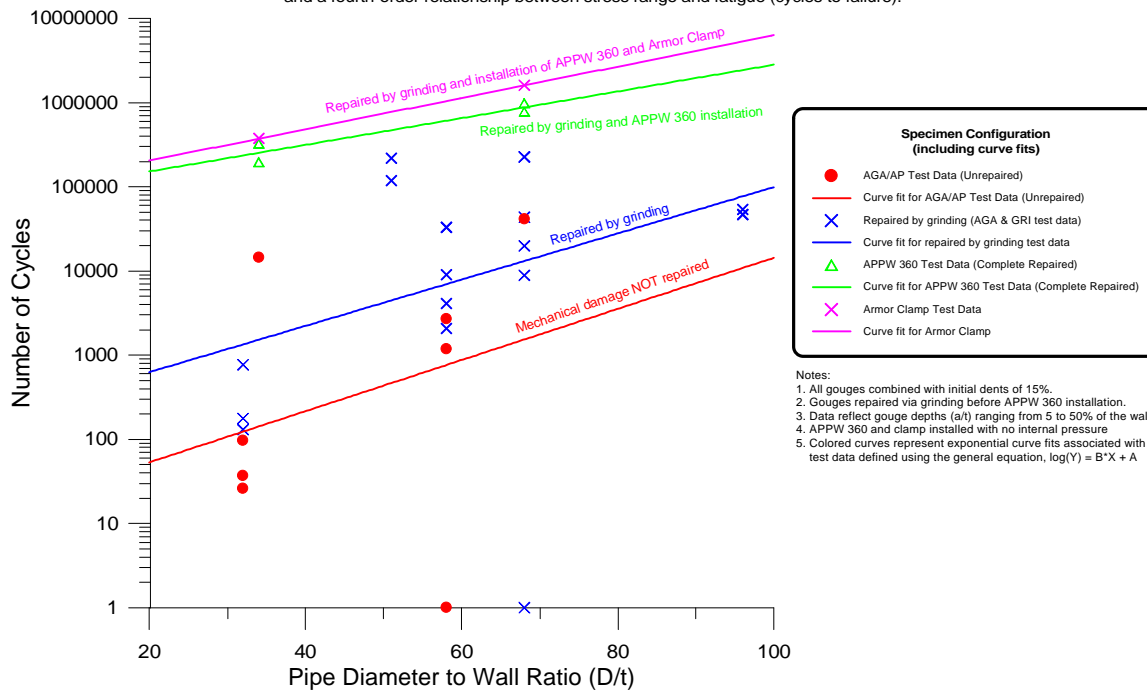
CYCLES TO FAILURE FOR MECHANICAL DAMAGE REPAIRED USING ARMOR PLATE PIPE WRAP

Data plotted for cycles to failure as a function of pipe diameter to wall thickness ratio. Equivalent fatigue numbers are plotted assuming an equivalent pressure range of 50 percent of the maximum allowable operating pressure using of Miner's Rule and a fourth-order relationship between stress range and fatigue (cycles to failure).

Figure 8 Fatigue data for dents and gouges in varying states of repair

Two modes of presentation are used. First, data is presented in tabular form. **Table 4** presents the raw fatigue data for the applied pressure range as well as a modified fatigue value that corresponds to a lower applied cyclic stress range. The second method of presentation is **Figure 8**, a plot showing cycles to failure for the test samples. Also included in this plot are test data from other research programs concerned with dents containing gouges (Alexander et al., 1998 and Fowler et al., 1994).

Figure 8 plots the cycles to failure for the samples repaired using APPW as well as the data for the two stainless steel clamps. Four sets of data are plotted.

- Unrepaired dents with gouges
- Dents and gouges repaired via grinding
- Dents and gouges repaired by grinding and installation of APPW
- Dents and gouges repaired by grinding, installation of APPW, and stainless steel clamp

- Samples *repaired by grinding* had fatigue lives that were approximately 10 times those of *unrepaired dents and gouges*.
- Those defects that were repaired by *grinding and APPW* had fatigue lives that were approximately 1,000 times those of *unrepaired dents and gouges*.
- Slight improvements were obtained over the grinding/APPW repair with the installation of the stainless steel clamp.
